Mask Set Errata 4

M68HC912D60 Microcontroller Unit

- 4F73K, available from January 1999.

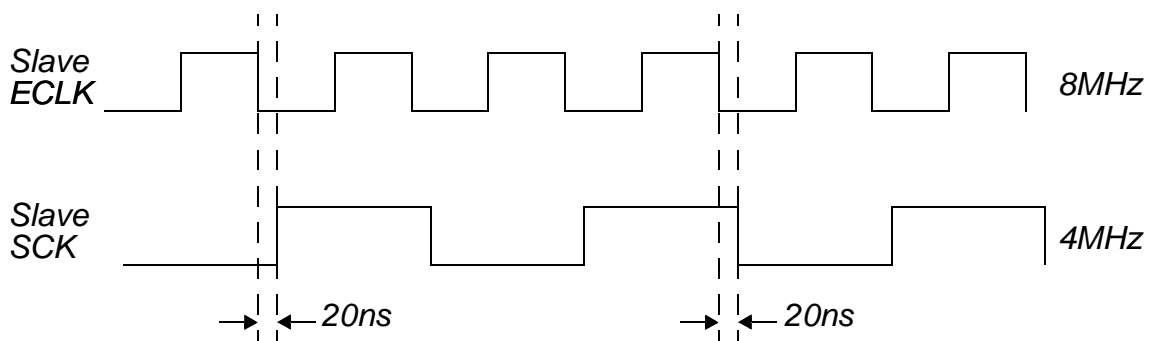
SPI: SPIF FLAG IS NOT SET WHEN OPERATING IN SLAVE MODE AR568

If the SPI on the HC912D60 is operated in slave mode, the SPIF flag is occasionally not set when valid data is received. The failing condition only occurs if the slave node's ECLK signals falling edge leads the SPI's incoming SCK signal by a specific phase difference.

NOTE: *The failure is very rare and has only been witnessed when the slaves ECLK falling edge leads the SCK by (20nS ± 4nS). The failure never occurs if the SPI is operated as the master. The diagram below shows an example of the timing relationship when the failure occurs.*

- Work-around**
1. Only use the SPI in slave mode if there is a fixed clock phase relationship between the master and slave clocks, avoiding the above scenario.
- OR
2. Implement a software timeout to gate reception of data. May require use of additional I/O for handshaking.

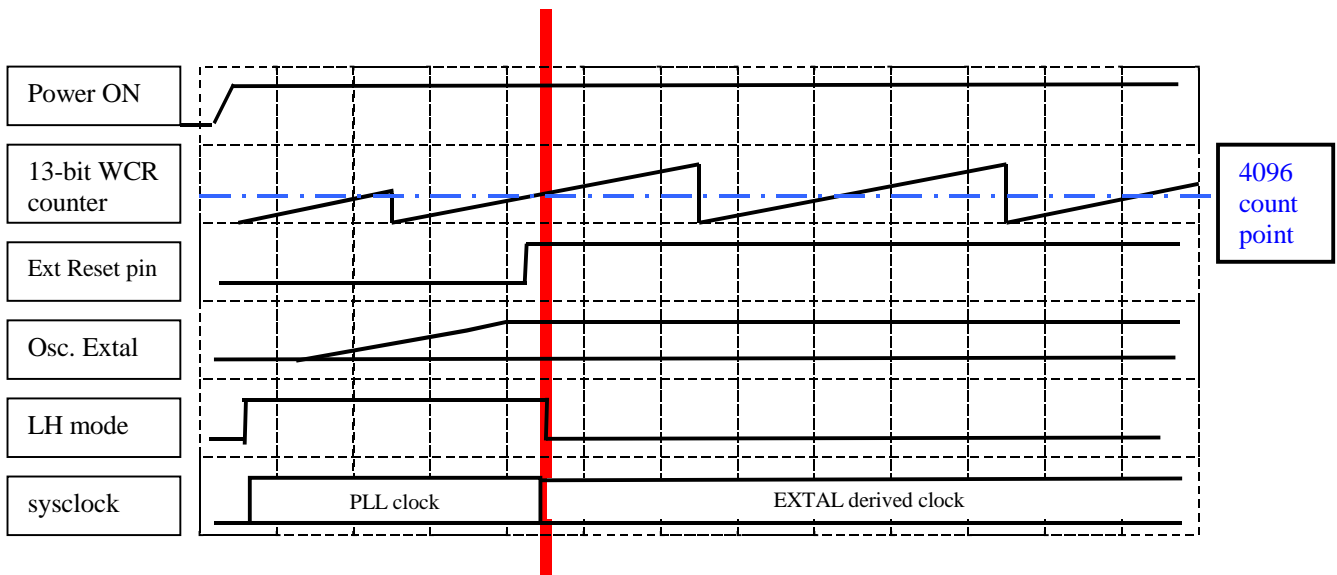
Figure 1. Representation of Normal start-up condition

Common practice for the start up mode of operation of HC12 microcontrollers is for the external RESET line to be held active until such time as the crystal has stabilized at its operating frequency. On release of the external RESET line and when the WCR (counter register) reaches a count of 4096 cycles, normal operating mode is entered with the CPU clocked from the crystal frequency (see fig. 1).

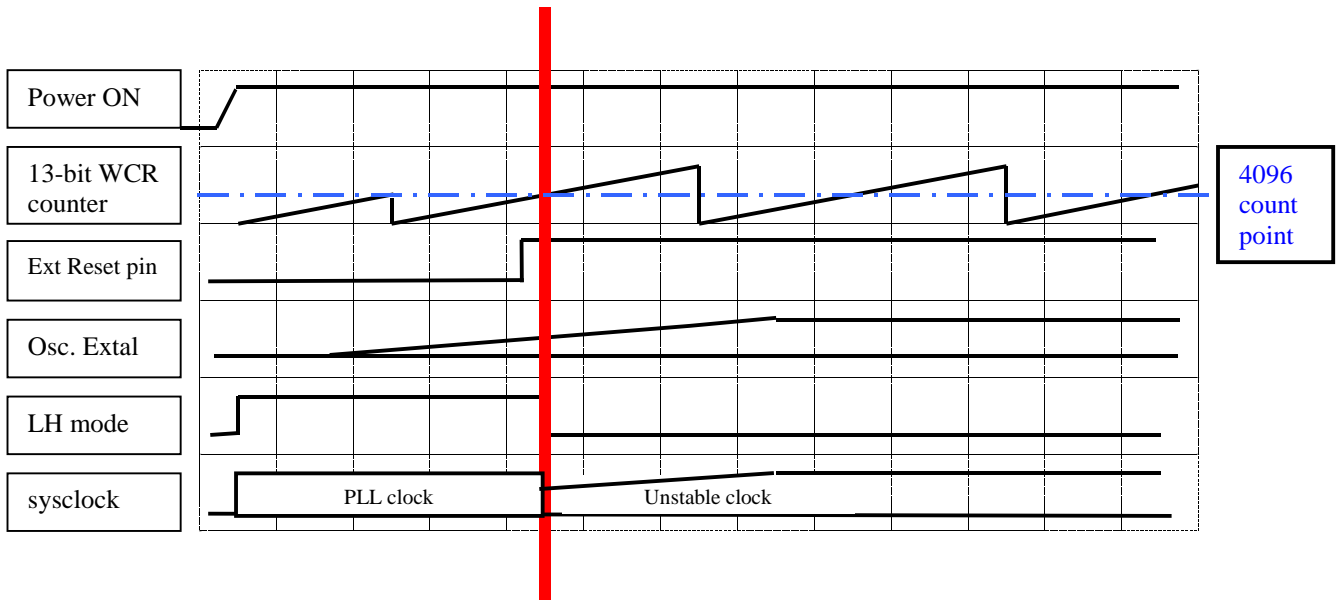
Figure 2. Representation of unreliable start-up mode with slow crystal

The HC12 mode of operation known as Limp-Home Mode (LHM) is enabled when the VDDPLL pin is at VDD and is entered if for any reason the external crystal ceases to oscillate. During this mode the CPU will be clocked from the free-running VCO clock of the PLL (at a nominal frequency of 1MHz). If LHM is enabled during the start-up phase (i.e. VDDPLL=5V, NOLHM bit=0) and the external RESET line is not held active until after the crystal frequency is stable then the device starts up

in LHM since no crystal oscillations will be detected. This situation can arise with short reset periods and/or crystals that exhibit slow start-up characteristics.

For the first 4096 cycles i.e. during the internal reset period, Limp Home mode will be de-asserted if oscillator activity is detected by the clock monitor circuit -due to the asserted Reset signal there can be no CPU activity during the Reset phase. Following release of the external or internal POR RESET in LHM (which ever is later) the crystal oscillator is sampled by the clock monitor circuit after another 4096 VCO clock cycles and at intervals of 8192 clock cycles thereafter until the crystal is deemed to be operating. If the crystal oscillator is showing activity at the time it is checked then it will be deemed to be good, even though it may not have fully stabilized, and LHM will be de-asserted. This can cause the device to switch from LH mode to normal mode with the CPU clocked from an unstable signal from the crystal oscillator (see fig. 2) resulting in unpredictable function of the CPU.
