68HC908JL3MSE1

## Mask Set Errata 1

# 68H(R)C908JL3/JK3/JK1 8-Bit Microcontroller Unit

## GLITCH ON TIMER BUFFERED PWM OUTPUT

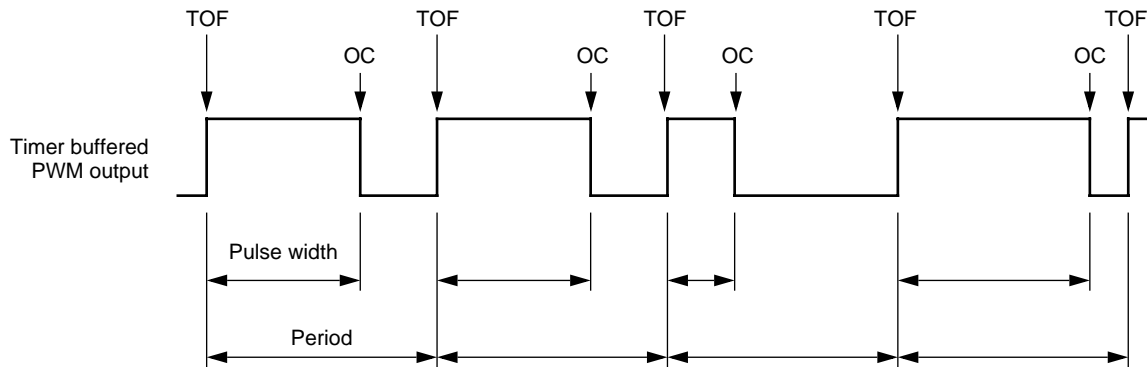
In timer buffered PWM operation, when a timer overflow (TOF) event or an output compare (OC) event coincides with a write to either pair of the timer channel registers (TCHxH/L), the duty cycle at the PWM output glitches to 0% or 100% momentarily, then returns to proper operation.

The figure below shows a typical timer buffered PWM output waveform, indicating the TOF and OC events.

Do not write to either pair of timer channel registers at:  
TOF (timer overflow), or  
OC (timer output compare) edges.

In buffered PWM, the pulse width is defined by the last written pair of timer channel registers.

To avoid the glitches when changing the PWM duty cycle, do not write to either pair of the timer channel registers at the TOF or OC.

For example, in the TOF interrupt service routine: If the OC occurs near the last TOF, write to the timer channel registers after the OC; if the OC occurs near the next TOF, write to the timer channel registers before the OC. A write to the channel register high byte (TCHxH) should immediately followed by a write to the low byte (TCHxL) to avoid TOF or OC occurring between the writes. Instruction cycle times must be included when making timing calculations.
