Mask Set Errata 3

MC68HC912DA128 Microcontroller Unit

- 5H55W.A

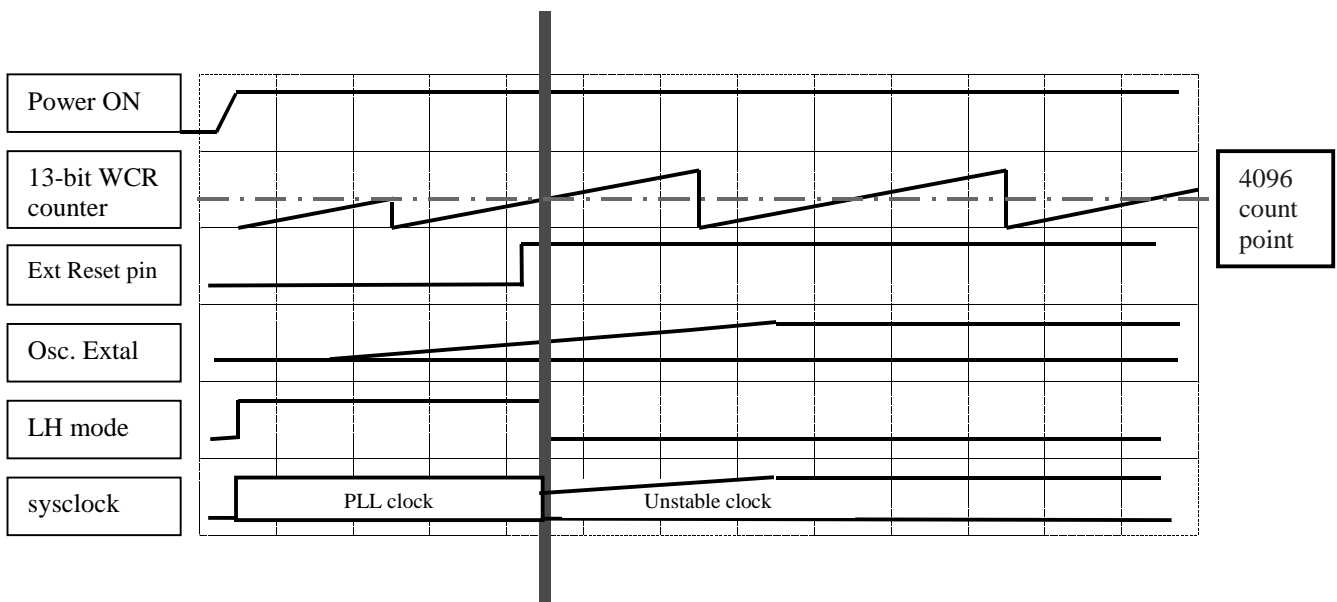
Figure 2. Representation of unreliable start-up mode with slow crystal

later) the crystal oscillator is sampled by the clock monitor circuit after another 4096 VCO clock cycles and at intervals of 8192 clock cycles thereafter until the crystal is deemed to be operating. If the crystal oscillator is showing activity at the time it is checked then it will be deemed to be good, even though it may not have fully stabilized, and LHM will be de-asserted. This can cause the device to switch from LH mode to normal mode with the CPU clocked from an unstable signal from the crystal oscillator (see fig. 2) resulting in unpredictable function of the CPU.
