68HC908LD64MSE1

Mask Set Errata 1

68HC908LD64 8-Bit Microcontroller Unit

GLITCH ON TIMER BUFFERED PWM OUTPUT

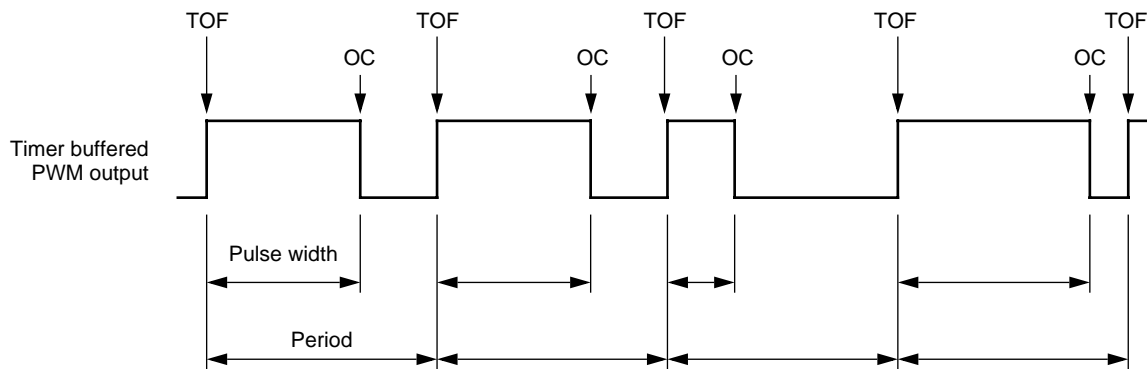
In timer buffered PWM operation, when a timer overflow (TOF) event or an output compare (OC) event coincides with a write to either pair of the timer channel registers (TCHxH/L), the duty cycle at the PWM output glitches to 0% or 100% momentarily, then returns to proper operation.

The figure below shows a typical timer buffered PWM output waveform, indicating the TOF and OC events.

To avoid the glitches when changing the PWM duty cycle, do not write to either pair of the timer channel registers at the TOF or OC.

For example, in the TOF interrupt service routine: If the OC occurs near the last TOF, write to the timer channel registers after the OC; if the OC occurs near the next TOF, write to the timer channel registers before the OC. A write to the channel register high byte (TCHxH) should immediately followed by a write to the low byte (TCHxL) to avoid TOF or OC occurring between the writes. Instruction cycle times must be included when making timing calculations.

Do not write to either pair of timer channel registers at:
TOF (timer overflow), or
OC (timer output compare) edges.
