Mask Set Errata 1

PC9S12DP256 Microcontroller Unit

- 0K36N mask of the PC9S12DP256

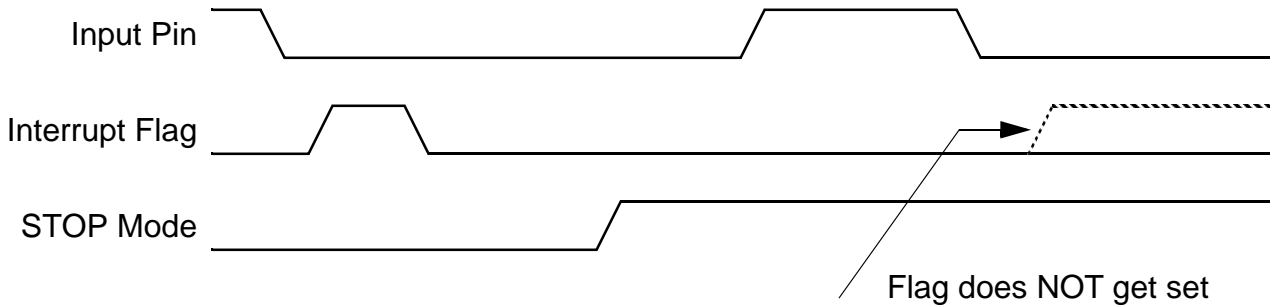
MISSING INTERRUPTS IN STOP MODE

MUCTS00191

No interrupt and therefore no exit from STOP is generated if the STOP mode is entered with an active level on the input line. This applies to all Port H, J, and P interrupt inputs.

Figure 1 Example shows falling edge sensitivity

Work-around Verify by software input level before going into STOP, in case of active level do not go into STOP mode.
