All modifications listed here refer to the PCB Revision 0.4

DF8OE, 06/20/2016

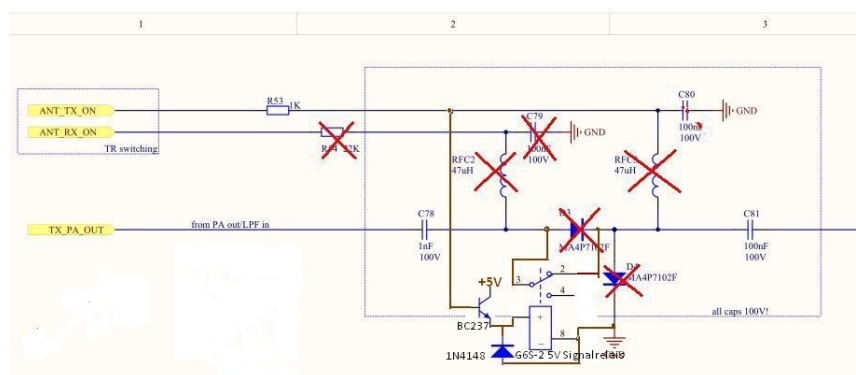
- (RF-04-H-029) The RF switch with two PIN diodes is problematic. The pin diodes have at lower frequencies (that is starting from 30m going down) significantly diode characteristics, which leads to a distorted transmission signal and power loss. Therefore, it makes sense to remove the entire switch: RFC2, RFC3, R54, C79, D3 and D4. For a 5V relay is fitted with NC contact.

This bridged-energized the connections of former D3. The work coil is connected to one end connected to ground, the other goes to an emitter follower (NPN standard transistor, eg BC237) thereof to the emitter, the collector goes to + 5V, the basis of the common terminal of R53 and C80. During transmission, the relay switches and disconnects from the receiver clean and completely. Not the freewheeling diode (LL4148, etc.) in the work winding forget! All this fits easily in the place where once there was the diode switching. Side effects, there is no - self CW-BK is still possible. [There are also photos](#) of such a structure. The modification (RF-04-H-007) has thus become naturally fell.

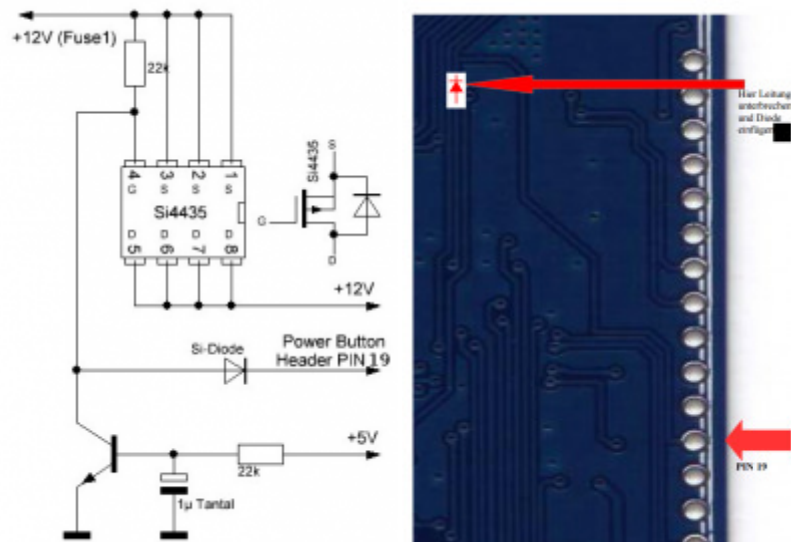
- (RF-04-N-009) The two gate resistors R81 and R82 were of 220R reduced to 100R (only if the amplifier at high output current fluctuation has).
- (RF-04-N-010) At high speaker volume, the ripple of the 8V supply voltage coupled to the receiver mixer. Why does the LF amplifier attached to the stabilized voltage as well? I have it connected with a FET connected directly to the 12V input voltage. This current changes will affect at high volume no longer to receive. Additionally, I have connected with this switched 12V input of 8V voltage regulator and the two voltage divider elements directly to the 12V. As a result, the quiescent current consumption in "off" mode is now fallen to less than 1uA. The following changes are necessary:

- On the ui board is the line "PC13" excoriated by the processor to the power switch and the header below the LCD and placed a diode in this line (anode to the processor out)

- On the rf board Pin4 is from U3 highly placed as well as the sides of R9 and R13, which will go to 12V. These three connectors are now merged with wire and attached to SW_12V the new circuit.

- The rest will be seen from the unique labels of the new circuit is wired. On the right, the place can be seen where the additional diode is installed. The site is located on the ui board below the LCD. The cathode of the diode is then in the picture above and below the anode (for STM32F4 out).

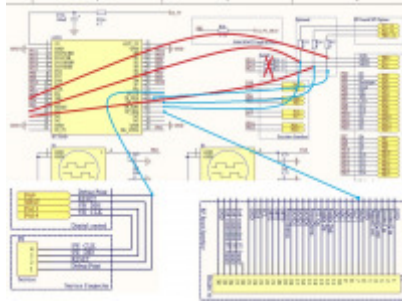
- (UI-04-N-026) If you want to activate the touch screen capabilities, has embarrassed five wires and R30 ... R32 unsolder (when the are loaded). The pin names are at the bottom of the LCD panel, I use these designations - the wires are laid but on the UI board itself. The wires do not interfere with the function of MCHF, even if the firmware does not yet support the touch screen! TP_IRQ hits the header Pin7 (== PA4 MCU), TP_SDO goes to the common terminal of R30 and R33, TP_SDI goes to the common terminal of R31 and R34, TP_SCK goes to the common terminal of R32 and R35 and TP_CS goes pin 1 of P8 (== PO9 the MCU). From the testing firmware 0.219.26.13 the touch screen is supported. Please note that the red wires are NOT necessary for the function of the touch screen. These wires are for the operation of the LCD in SPI mode required (UI-04-N-025). If one makes the touchscreen modification, it makes sense to do this modification with the same.
