MODEL: PL-2, 4, 5, 6, 7, 120, 220, 230, 320, 330, 420, 430, 620, 720, 730, 930

SUBJECT: POOR CONTACT POINTS IN THE SPEED SELECTOR SWITCH

SYMPTOM: TURNTABLE SPEED IS UNSTABLE, CAUSING WOW & FLUTTER

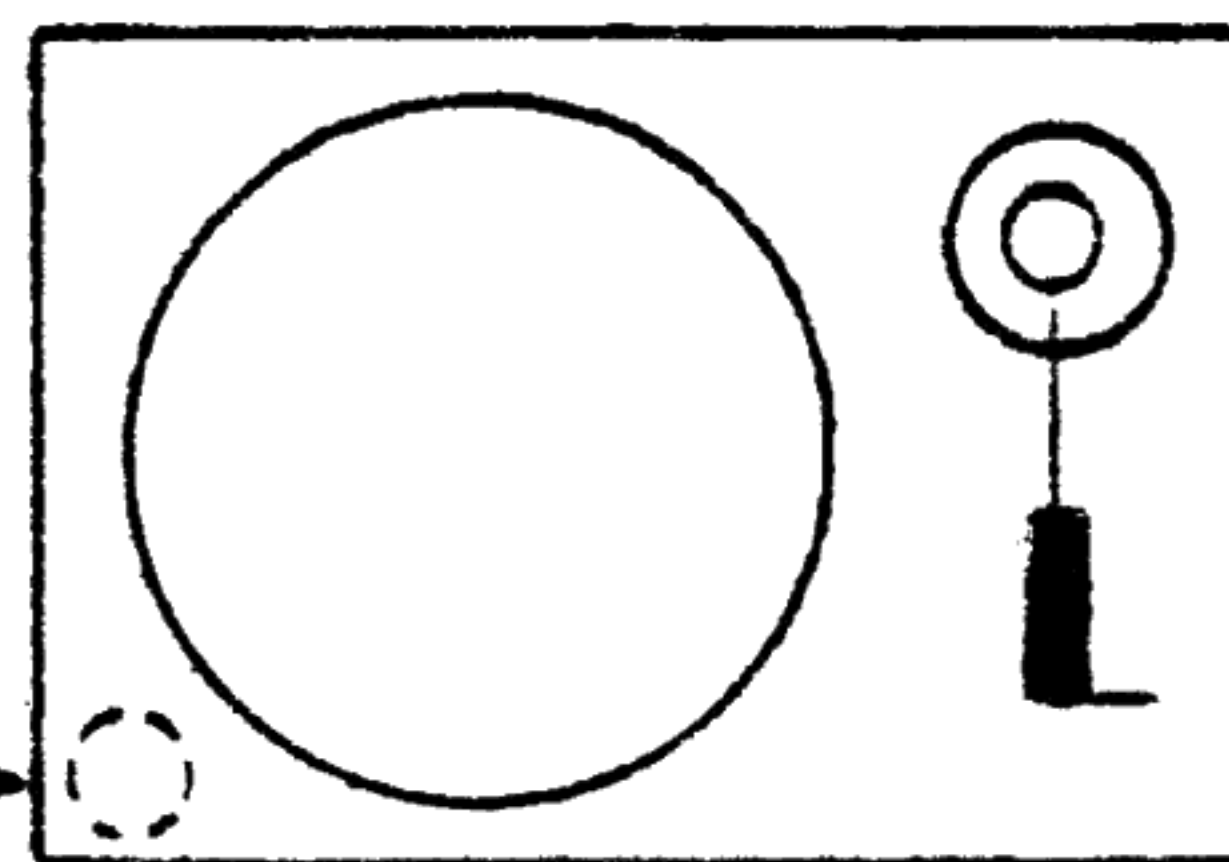
CAUSE: UNDER CERTAIN ENVIRONMENTAL CONDITIONS, A 'BLOOMING' OF THE RUBBER DAMPER CUSHION (PART OF THE FOOT) WILL OCCUR WHICH PRODUCES A SMALL AMOUNT OF SULFIDE GAS. THE SULFUR IN THIS GAS WILL ACT UPON THE SILVER ON THE CONTACT POINT SURFACE CAUSING A CORROSION WITHIN THE SPEED SELECTOR SWITCH. THIS CORROSION OF THE CONTACTS IN THE SWITCH WILL CAUSE THE UNSTABLE MOTOR SPEED.

The distance between the rubber damper cushion and the Speed Selector Switch has influenced the problem. If it is more than 40mm, the problem will not occur. However, the switch is close enough to one of the four rubber cushions and can be affected by this condition.

This Rubber Cushion is affecting the Switch

Only the Rubber Damper Cushion nearest to the Speed Selector Switch should be changed. To distinguish the new part, the color of the rubber is changed from BLACK (Butyl) to GREY (Silicone).

Note: When servicing a unit with this problem, please replace the switch and the rubber cushion at the same time. Also, note that it is only necessary to replace the rubber cushion that is nearest to the Speed Selector Switch. DO NOT replace all four rubber cushions in the unit.
