Mask Set Errata 1

M68HC912D60 Microcontroller Unit

This mask-set errata provides information pertaining to the following 68HC912D60 MCU mask set devices:

- 1F68K

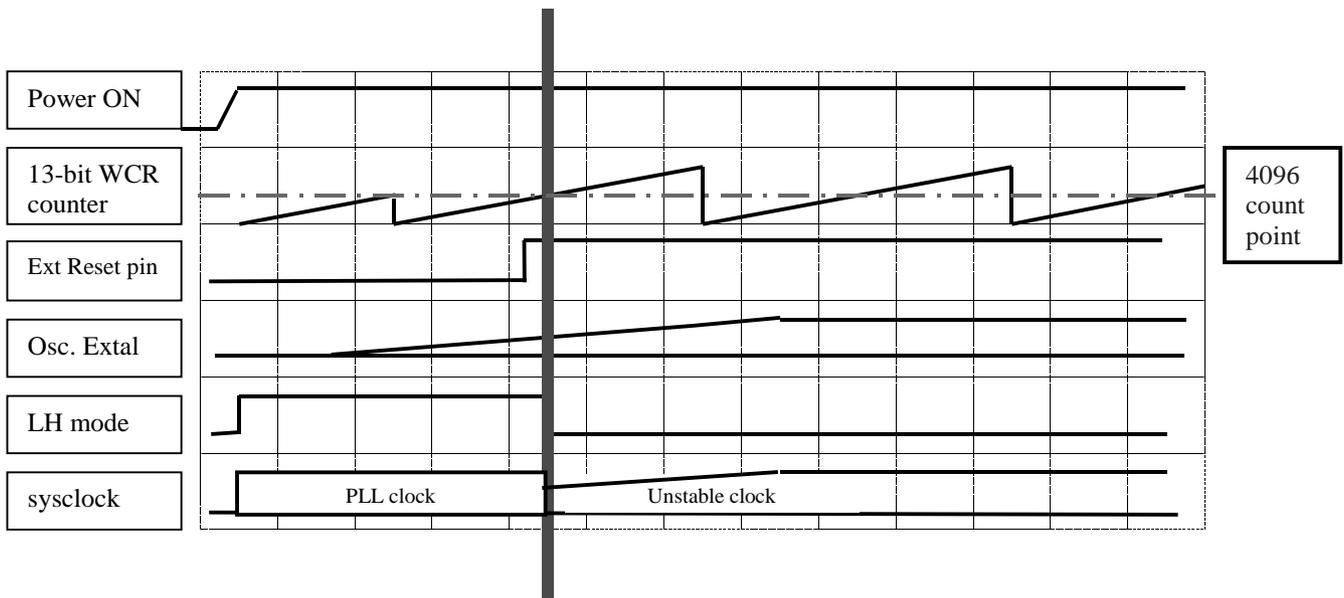
Figure 2. Representation of unreliable start-up mode with slow crystal

The device can prematurely indicate that the oscillator has stabilized releasing the part from Limp Home clock mode to the oscillator clock mode with an unstable oscillator. This can cause unpredictable behavior of the MCU. This situation can arise with short external power-on reset periods and / or crystal oscillator circuits that exhibit slow startup characteristics. If the PLL is not being used (Vddpll connected to Vss) Limp Home mode is disabled and this issue does not apply.

When exiting Stop mode (DLY=1) a similar 4096 cycle delay is executed and therefore this behavior could also show up at this time. In applications where this is likely to be an issue, using pseudo-stop is recommended as an alternative. Current draw will increase <100 μ A at 4MHz in pseudo stop versus stop mode.
