AN2167

Application Note

Changing Romeo2 Configuration Registers While RF Data Is Being Received

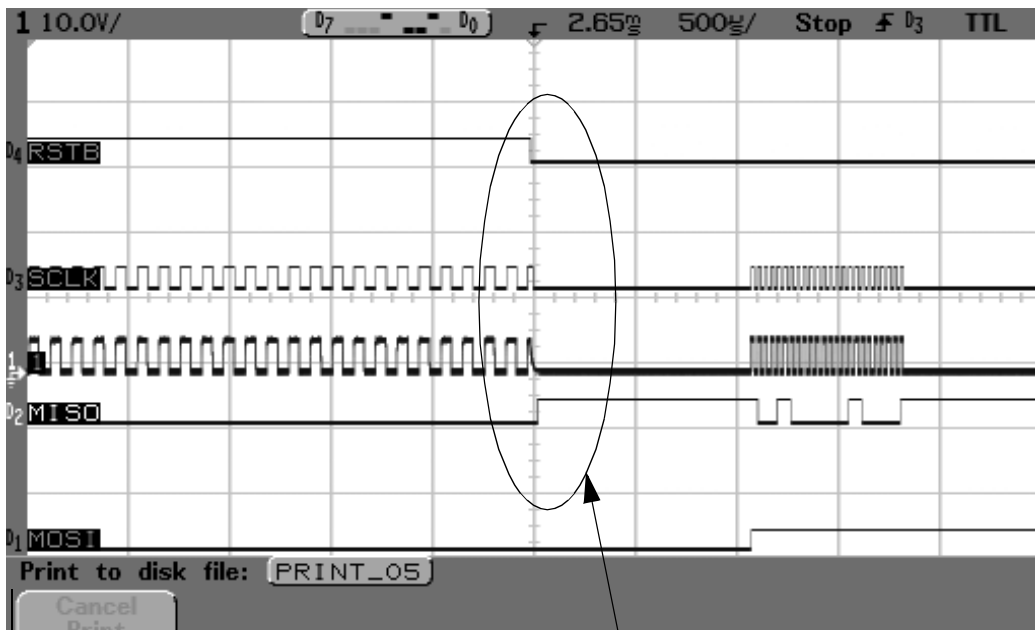
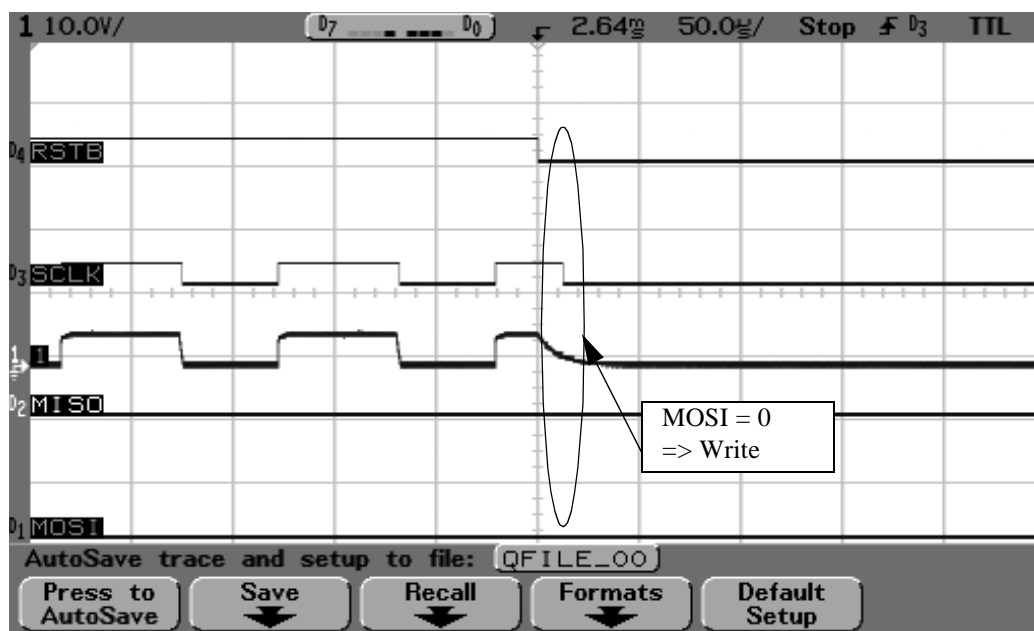
Figure 1

To change Romeo2 configuration registers, RSTb must be pulled down. A problem occurs if RSTb is forced low when SCLK is high. There is a time when the SCLK line is in a high impedance state (after Romeo2 is set as slave and before the MCU SPI is switched as master). Then, a first unwanted falling edge is generated on SCLK, either because the MCU forces SCLK low when it is set as master or because the SCLK voltage is discharged through device input capacitances (if the time is too long before the MCU is set as master). See Figure 1. This unwanted falling edge is understood by Romeo2 as a clock pulse. Then, Romeo2 starts to read (if MOSI is high at this unwanted edge) or write its configuration registers (if MOSI is low at this unwanted edge). The result is that the Romeo2 configuration registers may be corrupted, that a write is executed instead of a read, that a read is executed instead of a write, or that a read command is not correctly executed because one bit is shifted.

Trace 1 is the analog trace of SCLK.

With this example, the command is a read command. However, it is interpreted as a write command because MOSI = 1 at the unwanted falling edge. Since a read command was initially expected, MOSI is held as 1 for the whole command by the MCU. When MOSI = 1 during a write command, Romeo2 configuration registers are written as \$FF instead of being interpreted as a read command.

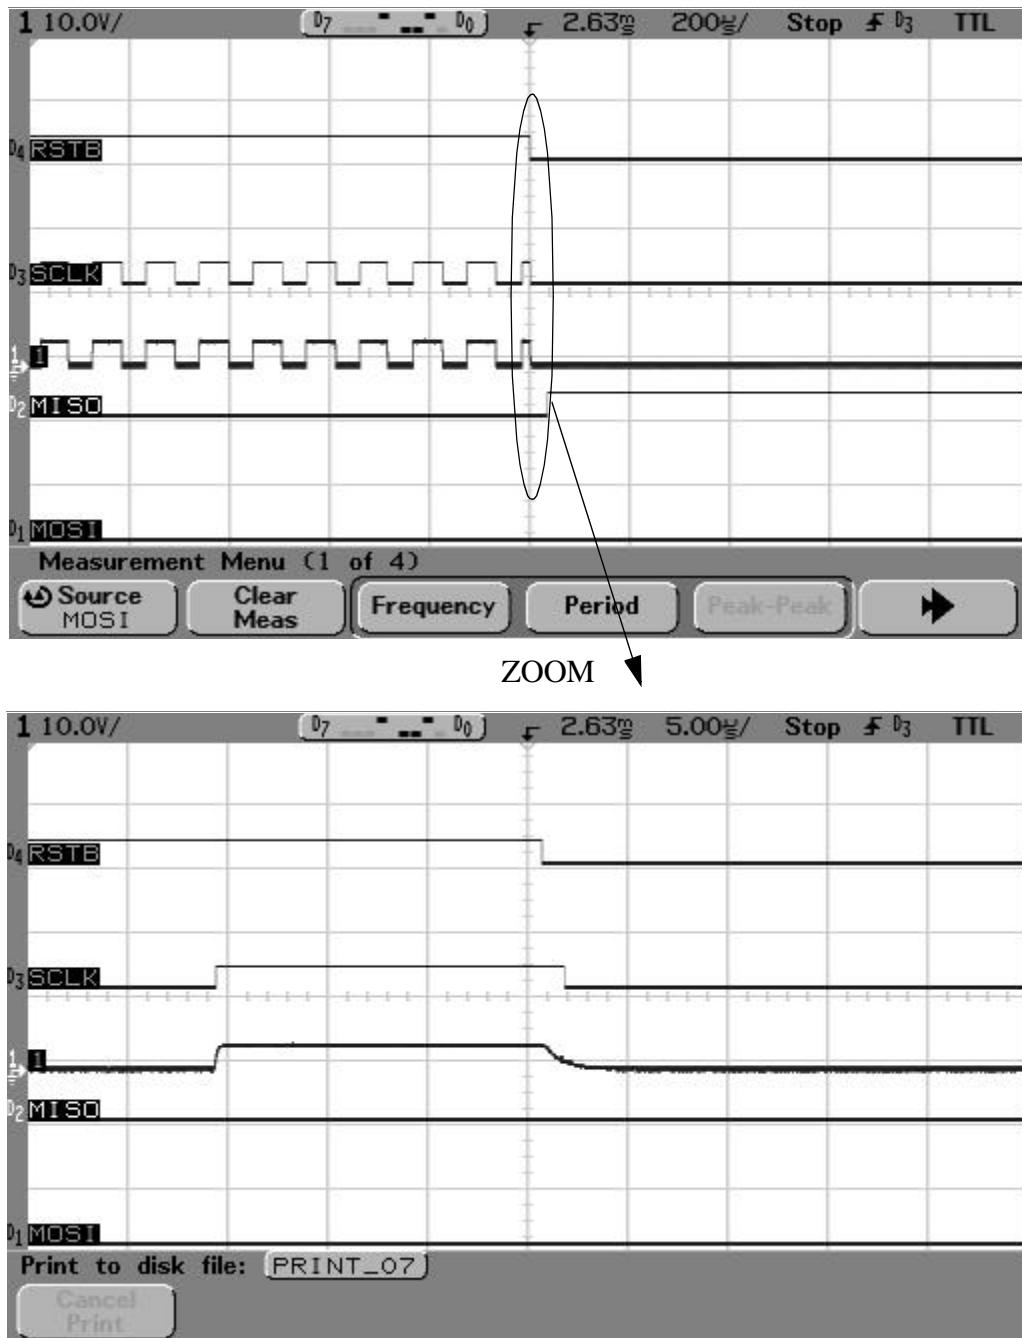
Figure 2

Inserting a pull-down on SCLK is a risky solution; as a matter of fact, SCLK is quickly discharged by the pull-down resistor during the time when both Romeo2 and the MCU are slaves. But an unwanted edge occurs and is delayed versus the time when RSTb is pulled down. The Romeo2 state machine resynchronises the RSTb command with its internal 615 kHz sampling clock. If it is set as slave before the time when SCLK is pulled down, it is then considered as a falling edge; the problem still exists. See Figure 2.

An unwanted SCLK edge occurs 1 μs after RSTb is pulled down. If it is understood as a clock pulse, the Romeo2 state machine is in trouble.
