THE MODERN DIESEL ENGINE:

**A DEPENDABLE EFFICIENT WORK
HORSE, BUT WITH AN APPETITE FOR
CLEAN GOOD QUALITY FUEL**

Authors: AJ von Wielligh Pr Eng BSc Eng (Mech)
 NDL Burger Pr Eng M.Eng (Mech) GCC
 TL Wilcocks B.Eng (Mech)

Staff of Department Mechanical and Aeronautical Engineering, University of Pretoria

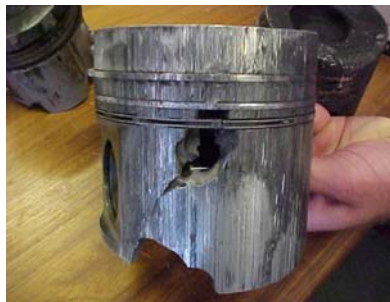
Figure 1: Holed piston.

The damage to these pistons are typical of that of a combustion related failure.

During the regular investigation of engine failures, it was found at a large portion of engine failed, due to the seizing of the piston in the cylinder liner. Very often this happened soon after overhaul. The nature of these failures are that the piston start seizing on the piston crown and this then gradually work its way down to the skirt of the piston. Several cases were also encountered were the piston crown started melting and in some cases holes were melted through the crown of the piston. Figures 1 and 2 shows the typically type of damage that piston sustain.

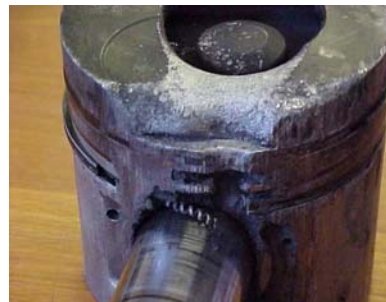
Figure 2: Damage to piston crown.

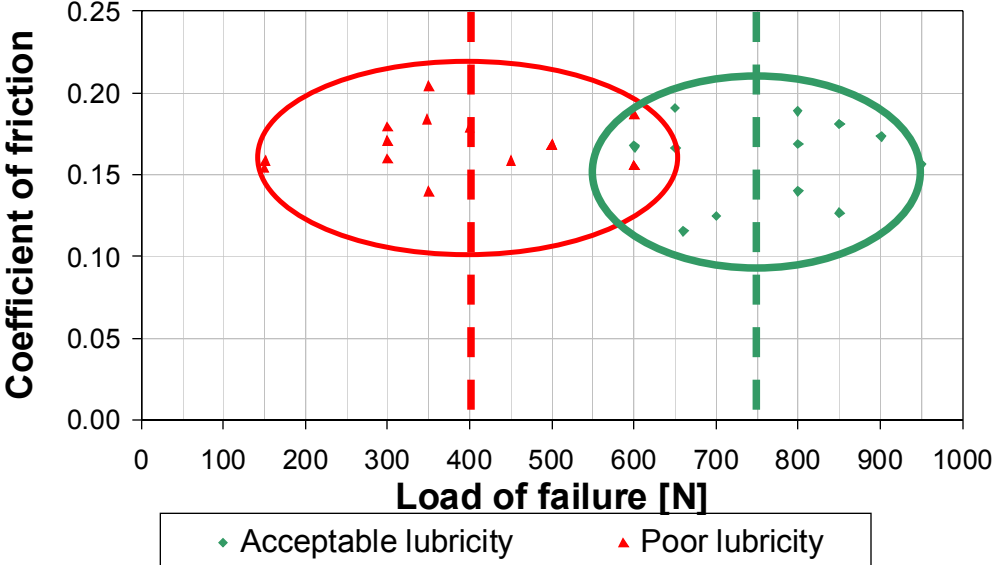
Graph A

reference. From failure analysis of several engines fuel samples were taken and these were tested on the SRV machine. It was established that typically a minimum load of 700N on the ball is required to prevent injector failures. This is not an exact figure, but as indicated by graph A the value seems to be a typical nominal value.

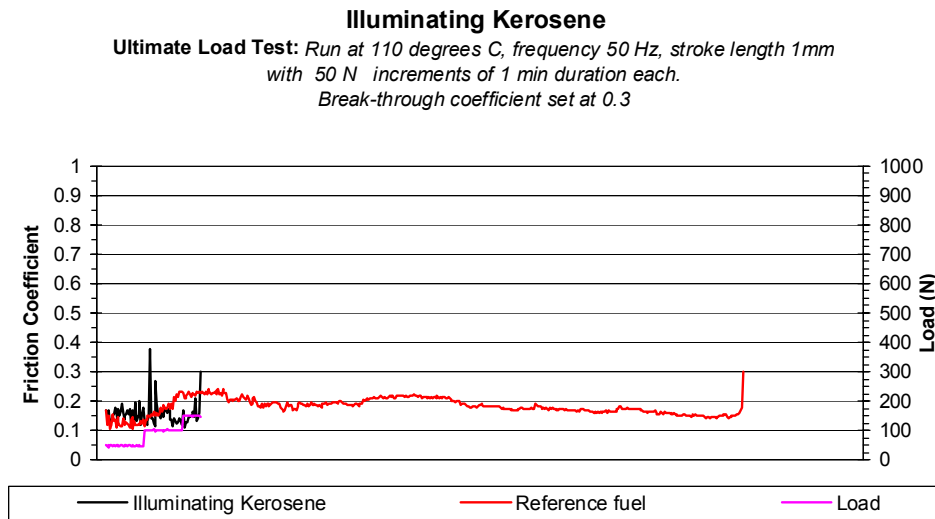
- 8.2 In graph 2, the results of the test on illuminating paraffin are shown. It can be seen from the graph, that a load of only 150N could be reached before break through occurs.

It must be noted that the above two fuels are the most common blending ingredients when diesel fuel is “spiked” in order to avoid taxation. It can therefore easily be understood that when this fuel is mixed with proper diesel that very poor lubricity will result.

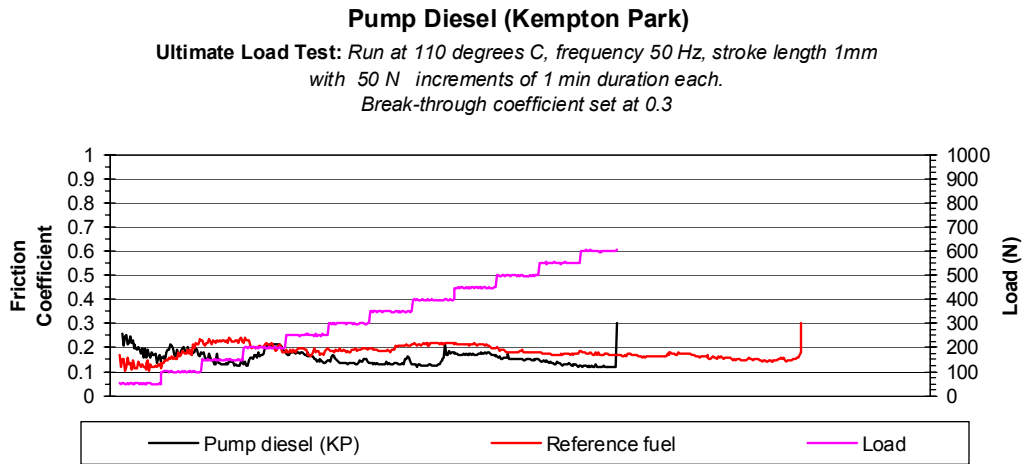
A few other filling stations were also tried in various towns in the country with mixed results. In graph 8, a fuel bought at a filling station in Kempton Park is shown. It can be seen from the graph, that the fuel could only withstand a load of 600N. This value is considered too low for the safe operation of a modern diesel engine.
