Mask Set Errata 3

MC68HC912DA128 Microcontroller Unit

- 5H55W.A

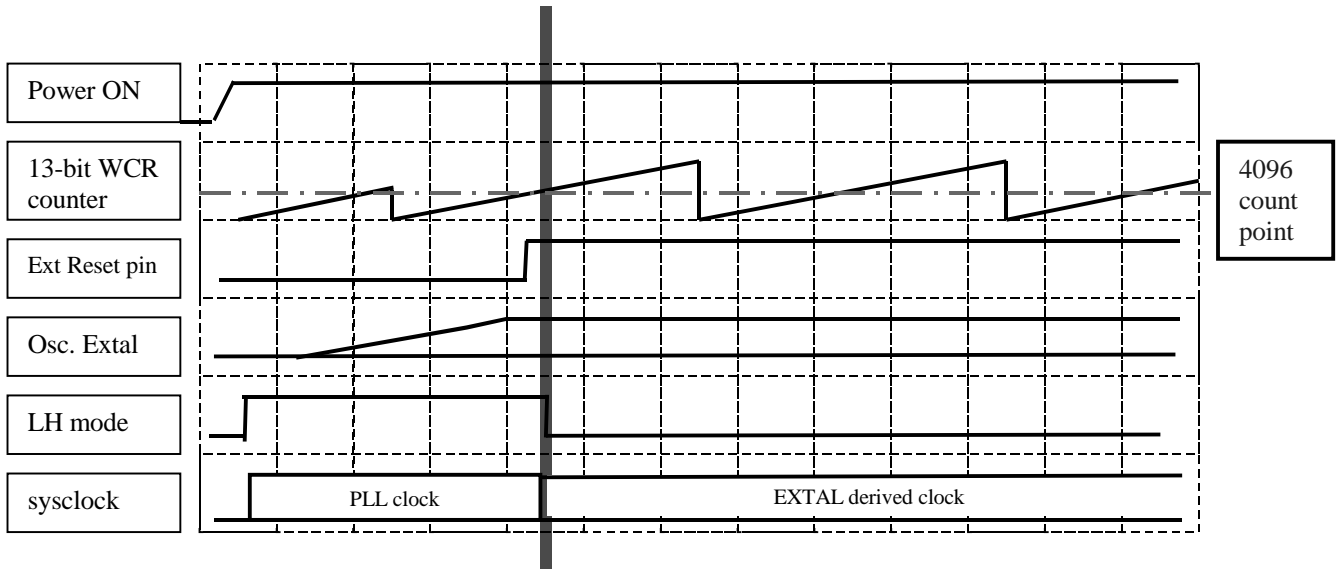
Figure 1. Representation of Normal start-up condition

Common practice for the start up mode of operation of HC12 microcontrollers is for the external RESET line to be held active until such time as the crystal has stabilized at its operating frequency. On release of the external RESET line and when the WCR (counter register) reaches a count of 4096 cycles, normal operating mode is entered with the CPU clocked from the crystal frequency (see fig. 1).
