Mask Set Errata 1

M68HC912D60 Microcontroller Unit

This mask-set errata provides information pertaining to the following 68HC912D60 MCU mask set devices:

- 1F68K

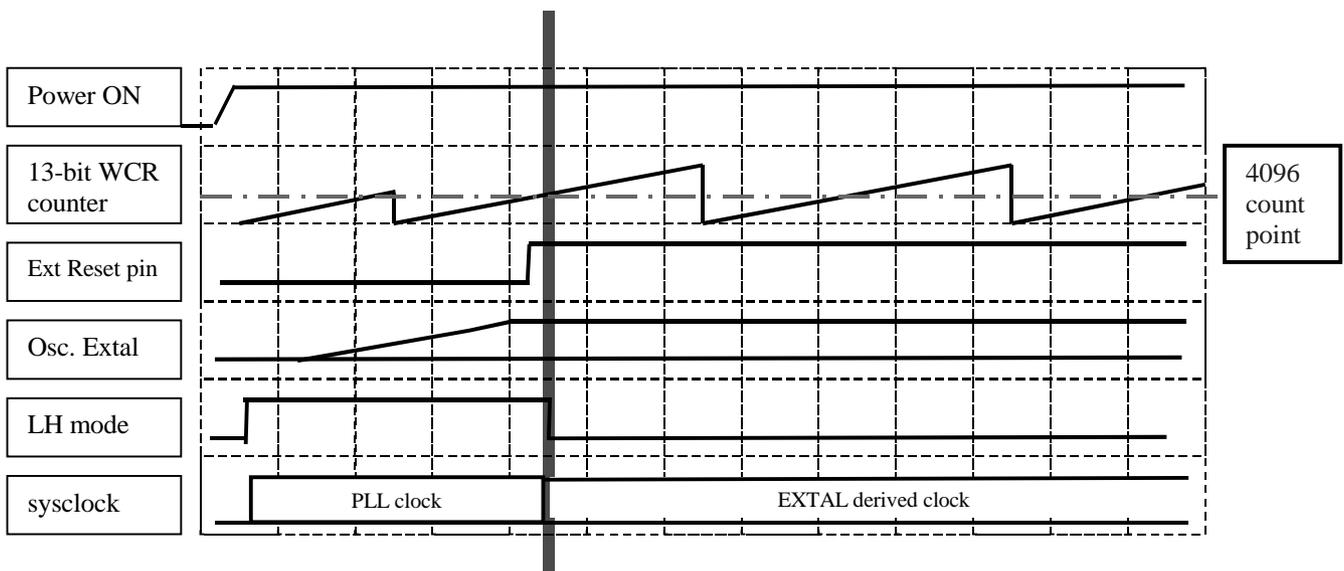
Figure 1. Representation of Normal start-up condition

The device can prematurely indicate that the oscillator has stabilized releasing the part from Limp Home clock mode to the oscillator clock mode with an unstable oscillator. This can cause unpredictable behavior of the MCU. This situation can arise with short external power-on reset periods and / or crystal oscillator circuits that exhibit slow startup characteristics. If the PLL is not being used (Vddpll connected to Vss) Limp Home mode is disabled and this issue does not apply.

when the WCR (counter register) reaches a count of 4096 cycles, normal operating mode is entered with the CPU clocked from the crystal frequency (see fig. 1).

The Reset condition can be overcome by allowing the crystal oscillator circuit to stabilize before releasing the external RESET line (see fig. 3). Operation is similar to that shown in fig 2.

In some applications it may be possible avoid this issue by delaying the connection of Vddpll to Vdd until the device has exited reset. This will sacrifice the limp home mode safety function upon startup, i.e. the part will no longer be able to start without a functioning crystal. A similar technique (disable PLL under software control) can be used to overcome the limitations of Stop mode.
